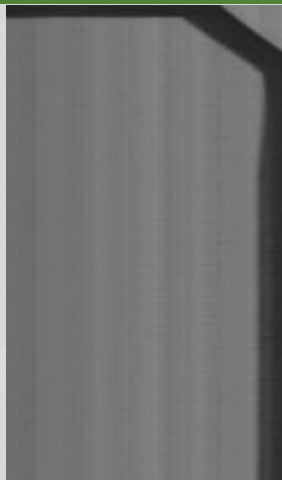
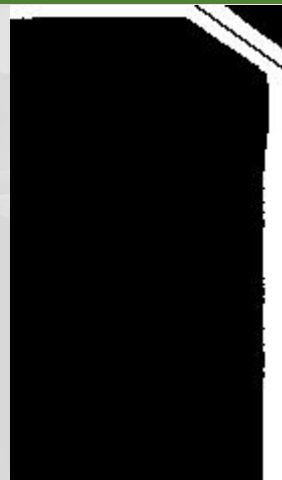
3 倒角異常

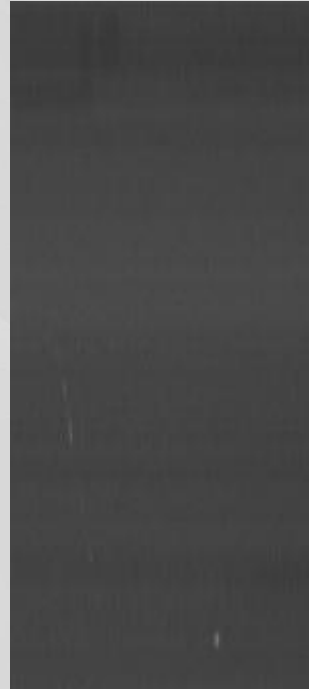
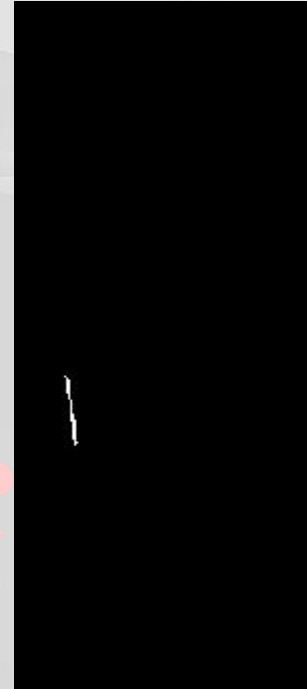
4 刮傷

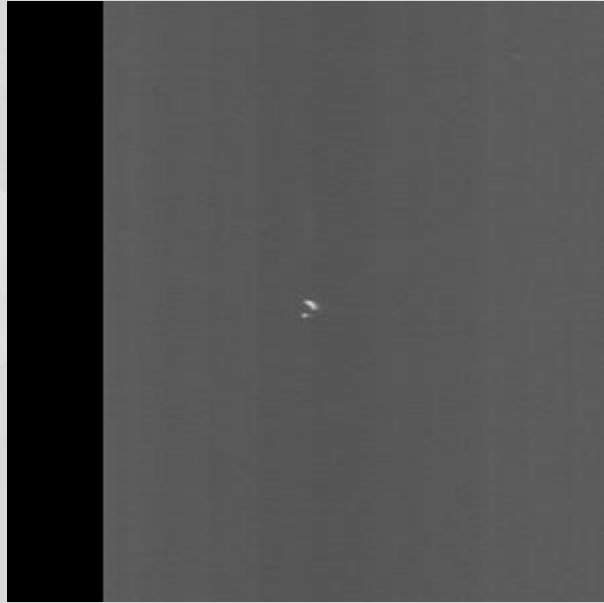
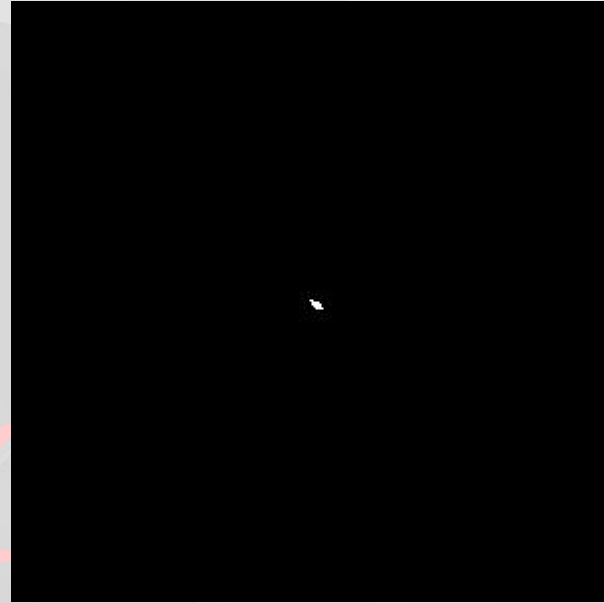
5 黒/白点 (紫傷)

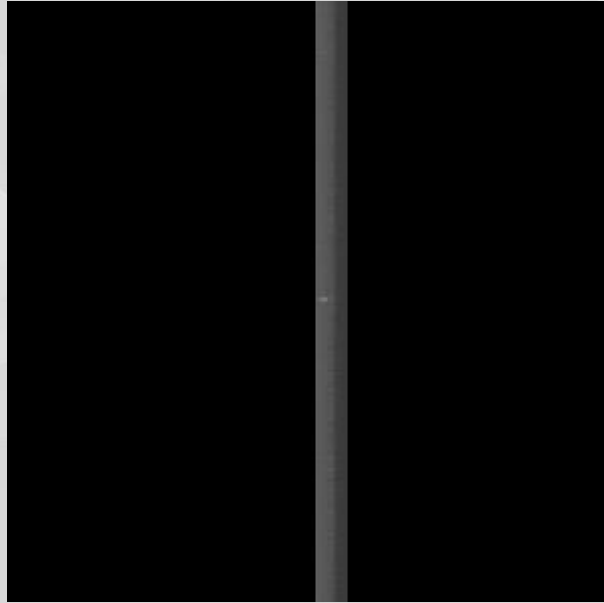
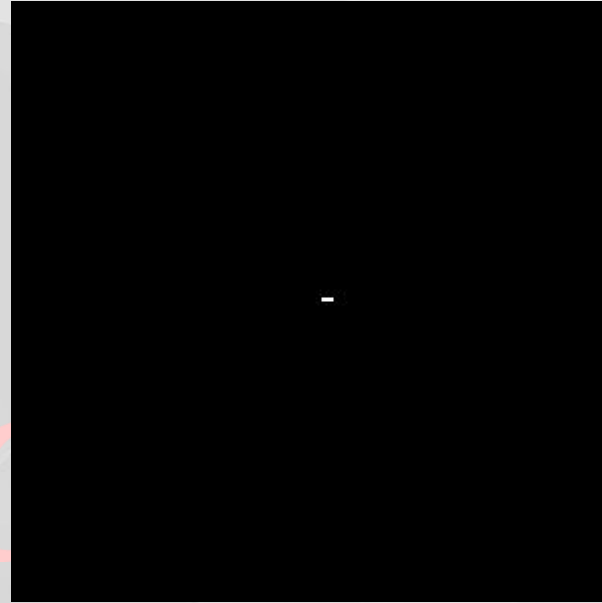
6 針孔

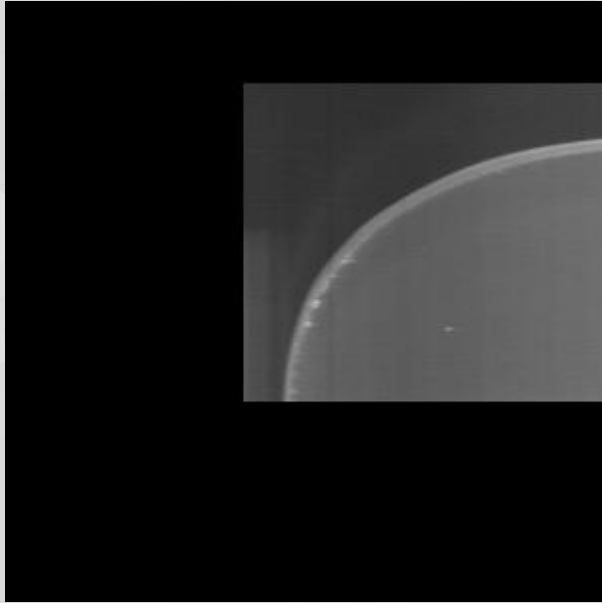
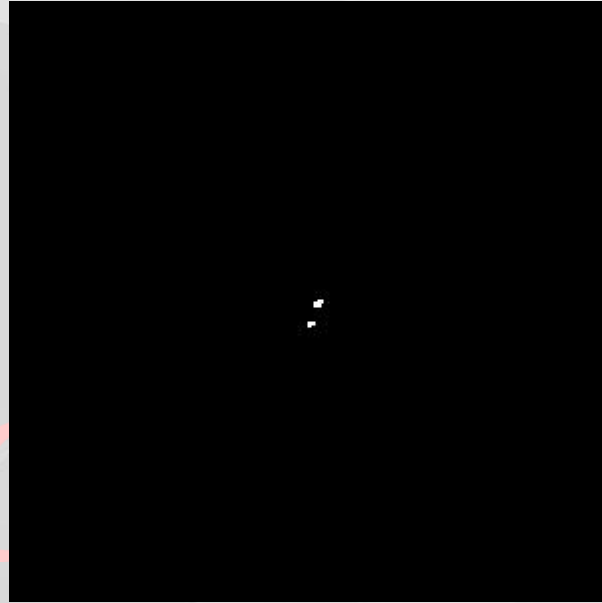
7 印刷不良

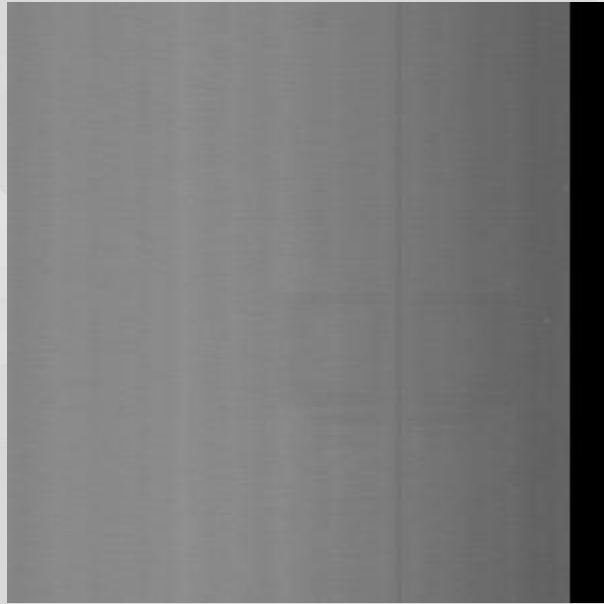
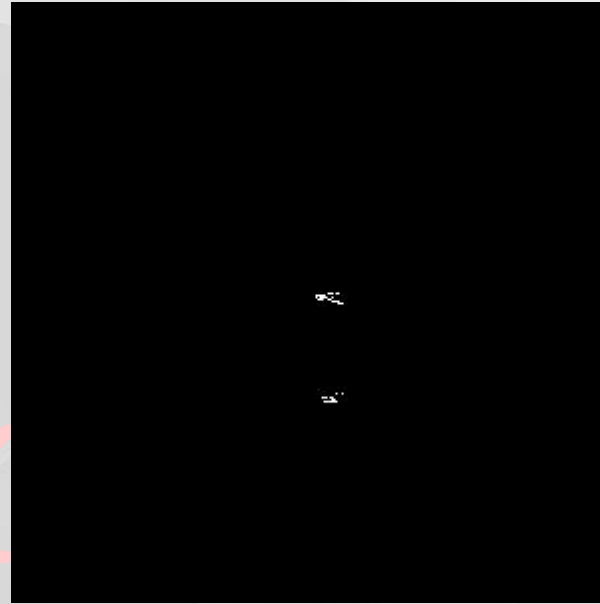
8 脏污(灰尘)

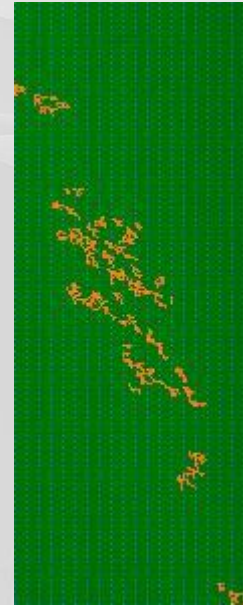
16 AG 陰影

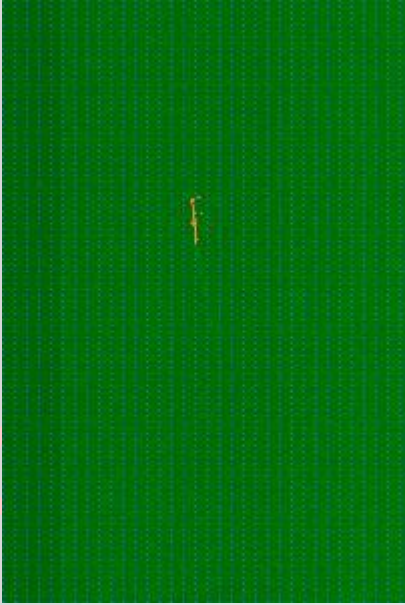
20 刮傷(AG)

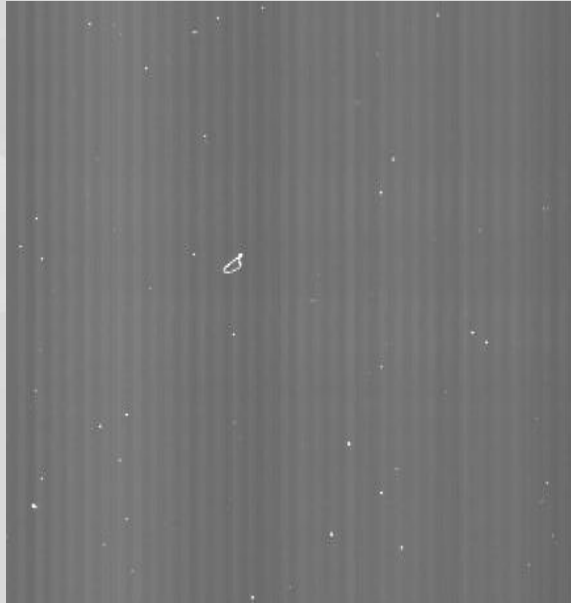
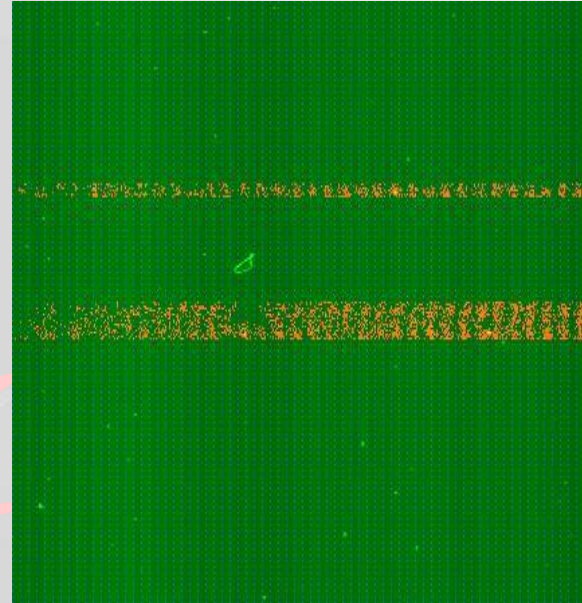
22 原材刮傷

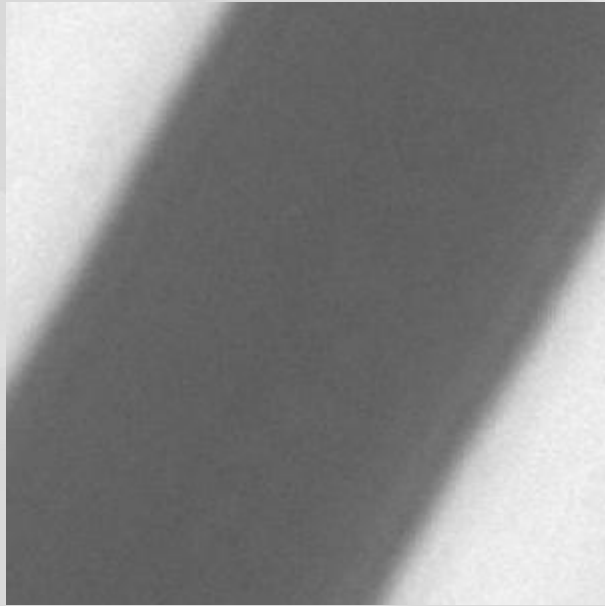
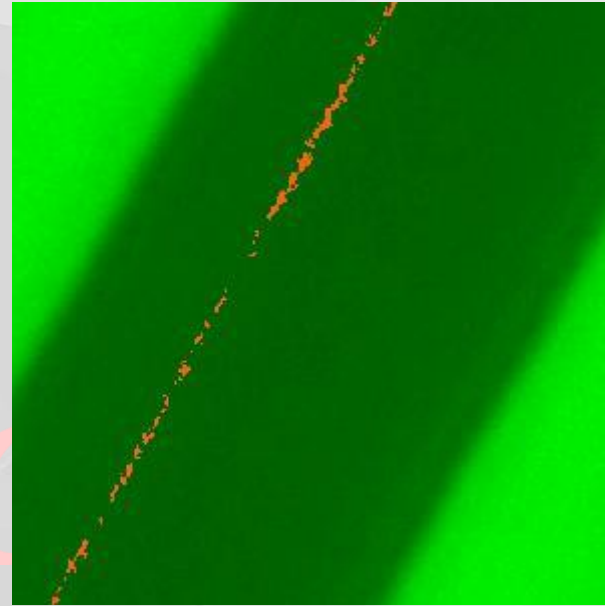
1 蝕刻不良

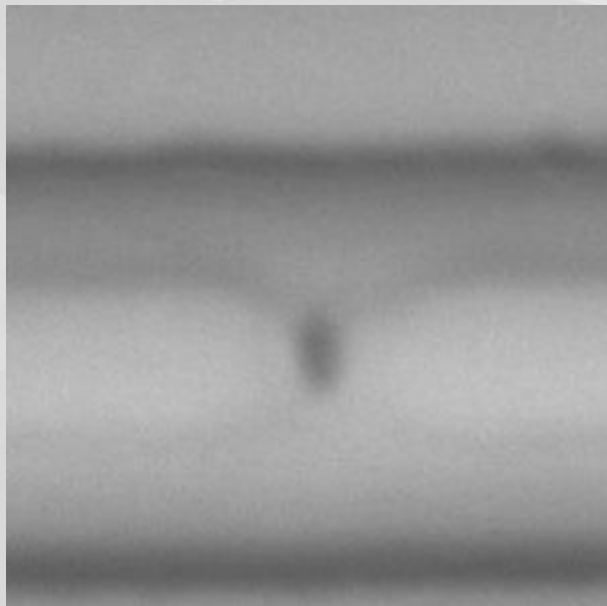
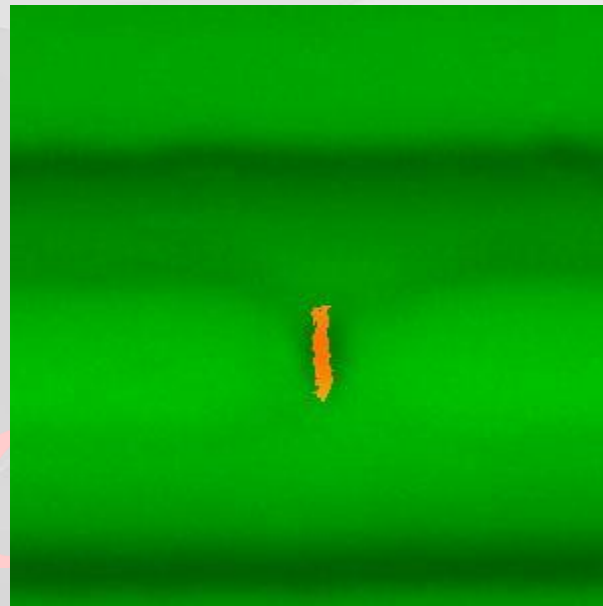
2 蝕刻斷裂

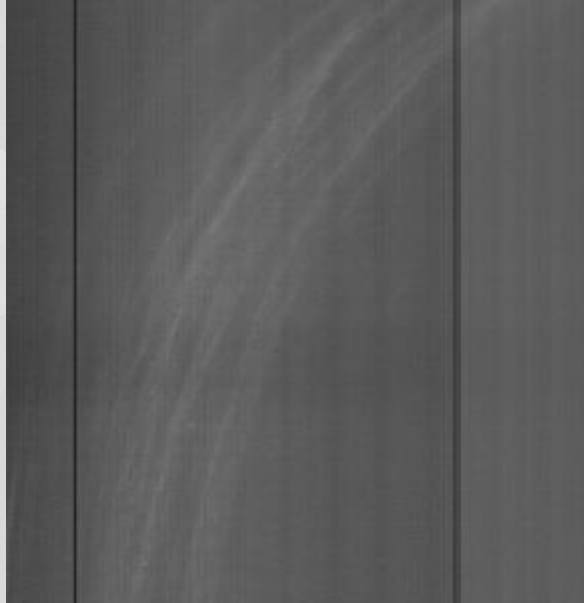
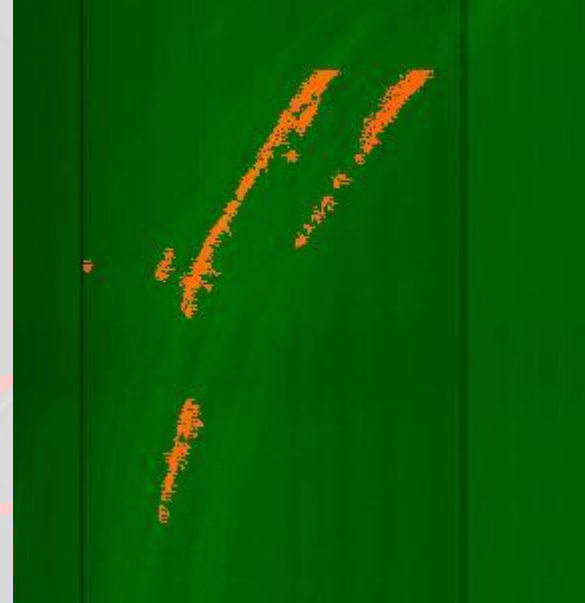
3 混料

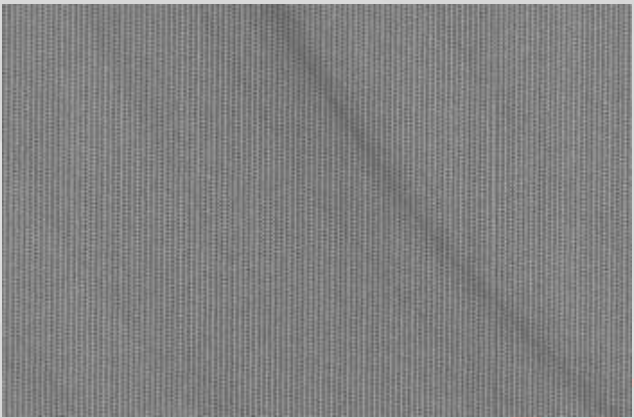
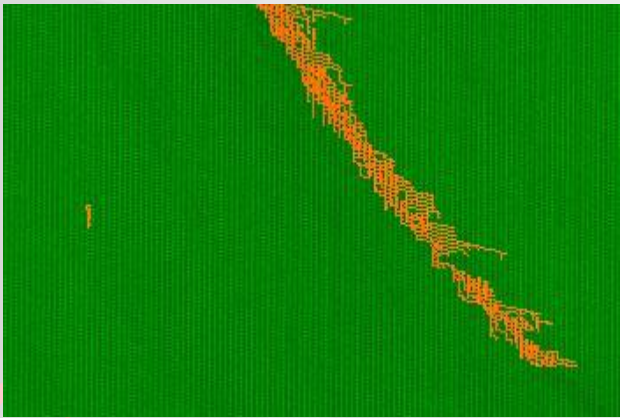
5 摩擦痕

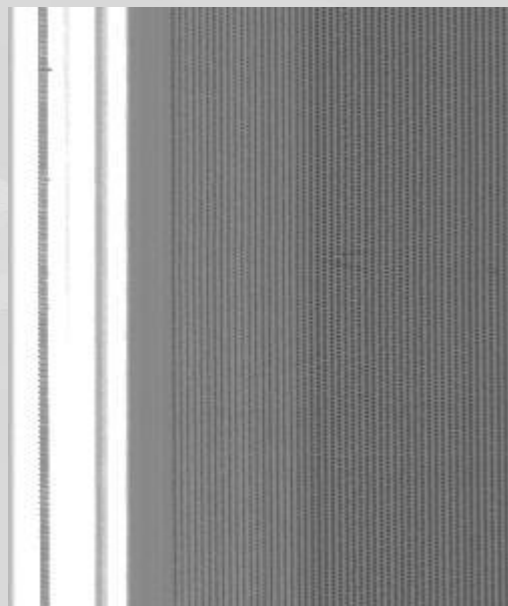
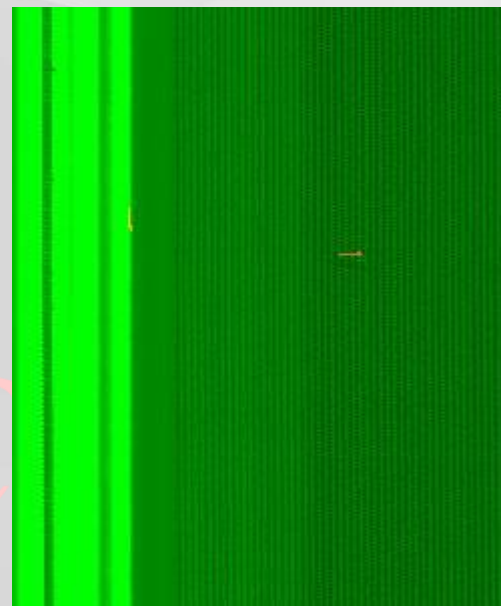
9 暗線

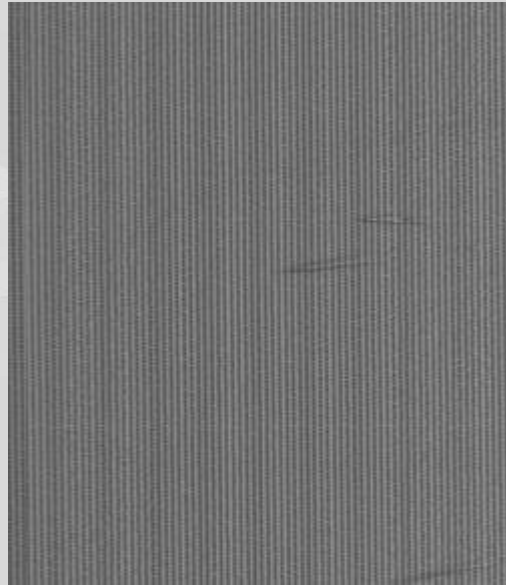
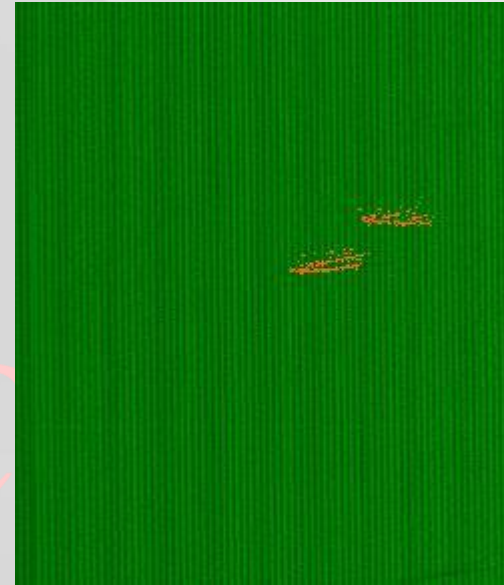
10 卡料

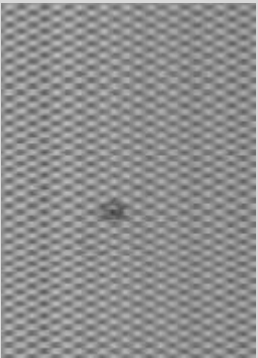
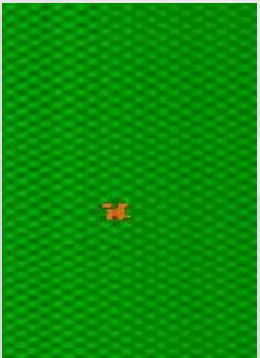
15 氣泡

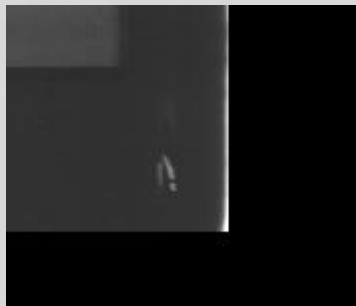
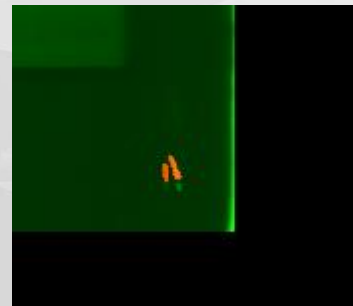
2 印刷不良

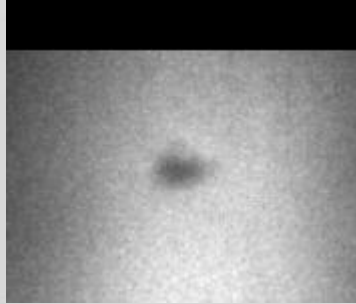
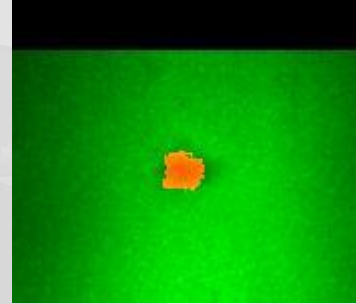
3 髒汙

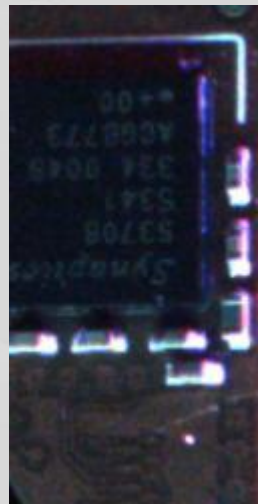
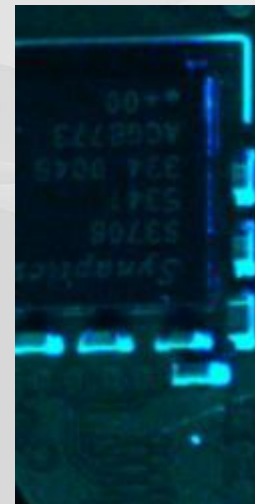
6 缺藍色保護貼

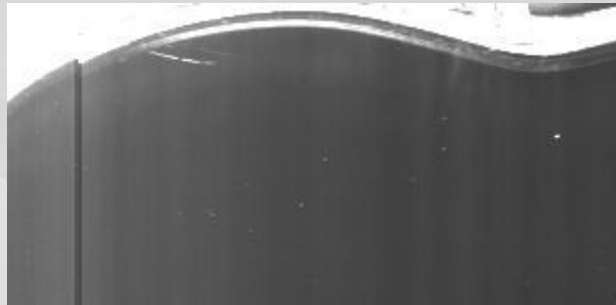
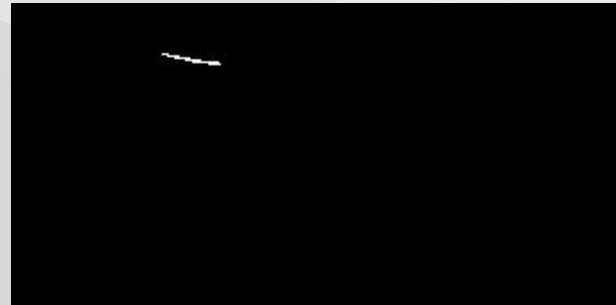
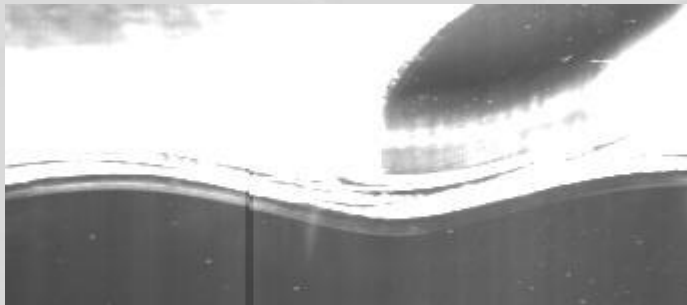
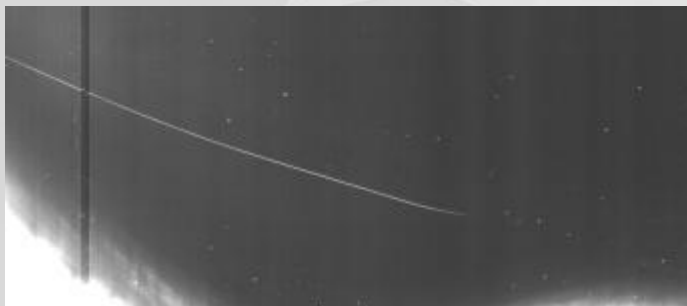
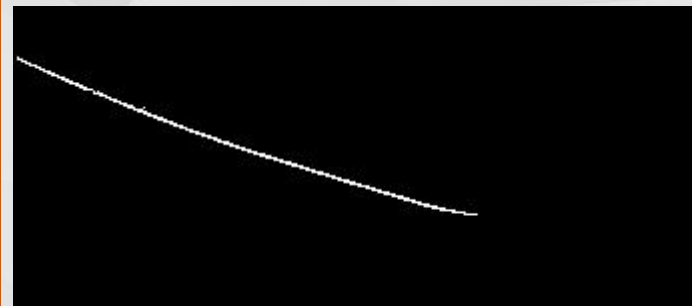
1 刮傷

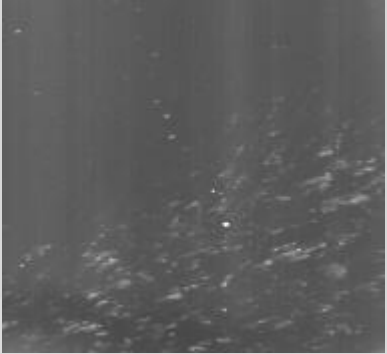
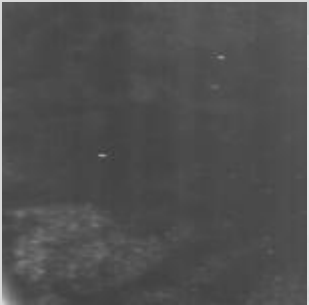
2 汚染物

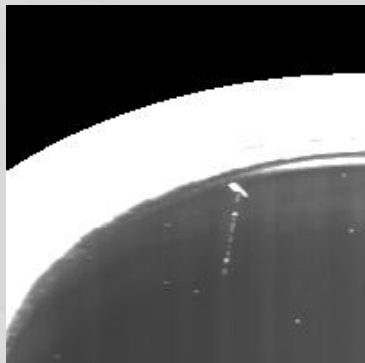
3 條紋

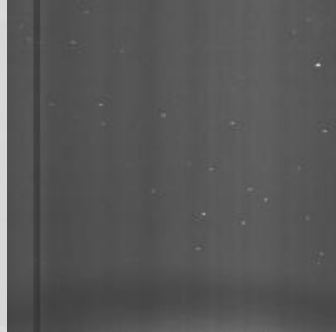
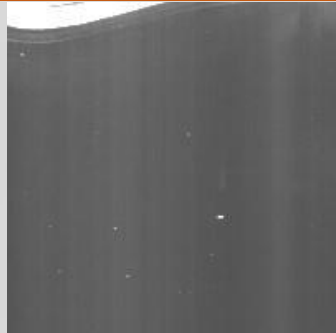
4 針孔

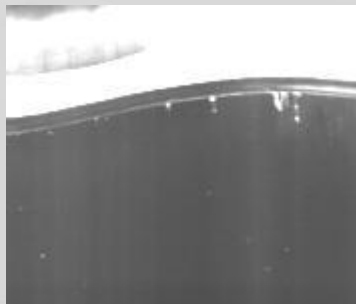
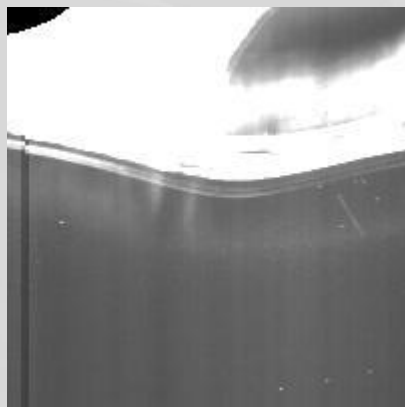
5 糊狀的邊緣

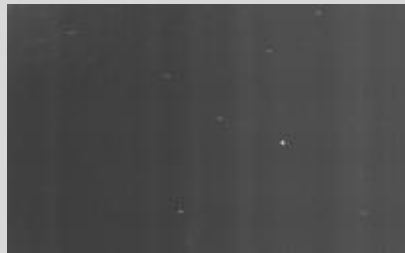
6 鑄斑

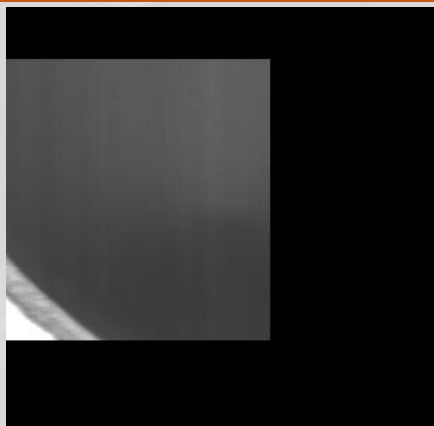
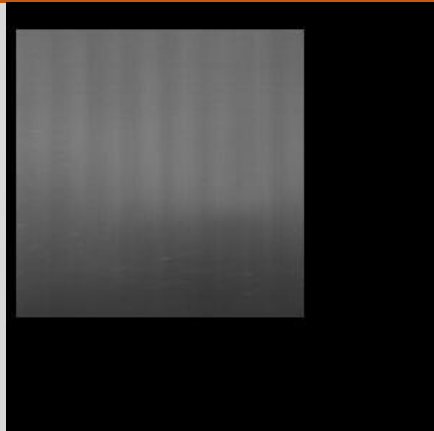
8 凹痕
