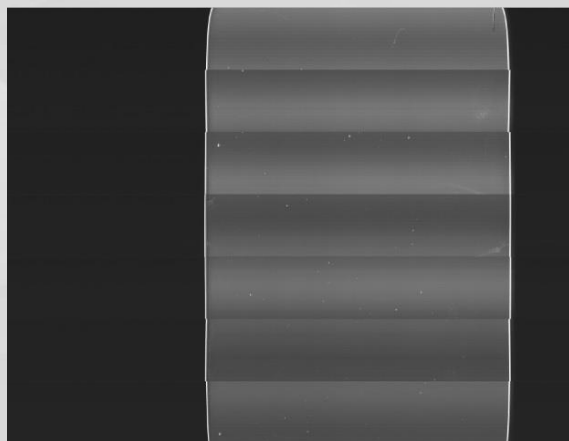
11 透光率

Transmission

115.7769

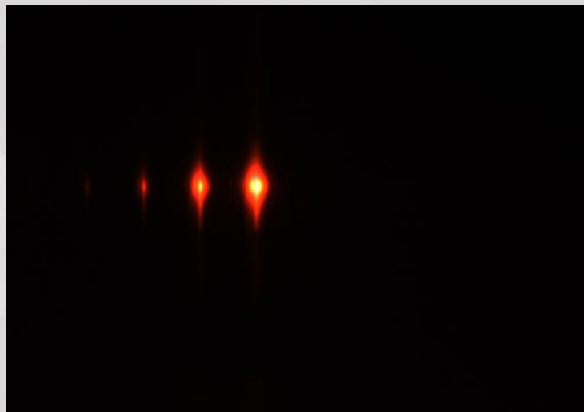
14 CG 厚度

Pixels	Thickness(um)
193	1072

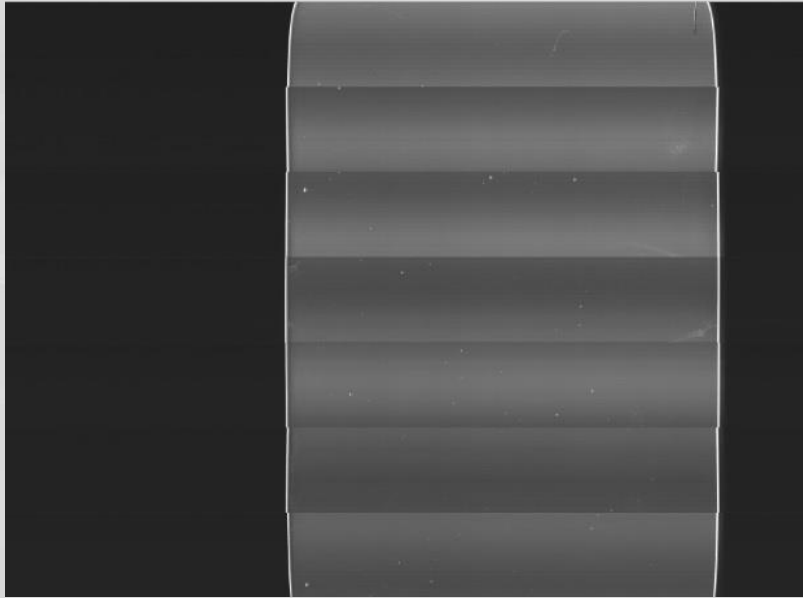
15 AG Gloss 反射率

Reflection

102.8188
